REPORT OF THE AUDITOR-GENERAL

PERFORMANCE AUDIT ON

CLIMATE CHANGE ADAPTATION ACTIONS- FUNAFUTI RECLAIM LAND

Date: 16/06/2025

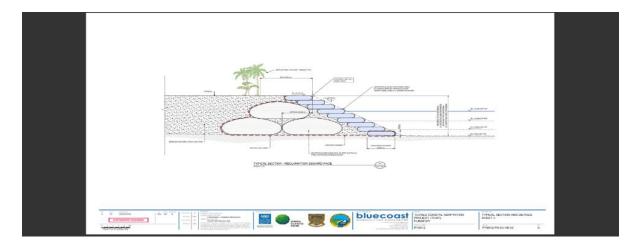
Figure 2. Funafuti Reclaim land Mega Bag Retaining Structure. Source (TCAP Funafuti Detail Design Report).

For example, the plan explains that the lagoon foreshore of the reclaimed land will be hardened with a well-designed and well-built retaining wall (bunding). The concept design of the bunding will be formed from geotextile mega bags overlaid with a protective layer of smaller geotextile bags (see Figure 2). The surface of the reclaimed area will be graded to drain into stormwater channels on the landward side. The drains will be open channel drains with crossing points provided at intervals along its length. The open channel drains will be designed such that overland flow through the existing coastal village (of Vaiaku) will also drain into the channel.

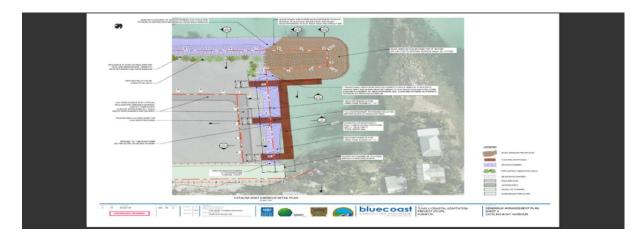
Figure 3. Catalina Harbor (TCAP Funafuti Detail Design Report).

The plan also explains that the TCAP reclamation works will incorporate improvements to the small boat harbour at the northern end of the reclamation area, at the site of the existing Catalina Harbour and boat ramp area (see Figure 3). The harbour will be protected by a breakwater made from rocks and will be fitted with bollards along its length for securing vessels. The harbour wall will be approximately 70m long and will be able to berth small fishing vessels typically used in the area. The harbour will be accessible at all tides, it will be a public facility, and the primary point of access from land will be over the reclaimed area.

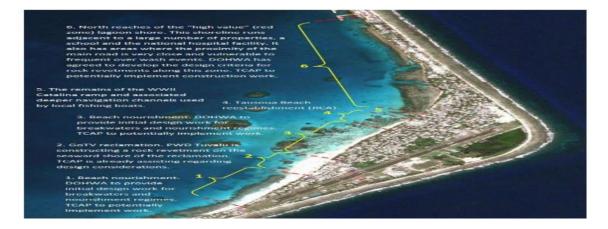
Figure 4. High value shoreline of Funafuti zoned and discussed to inform the final location selection of TCAP. (TCAP Technical Report: Evaluation of Priorities and Options to Address Coastal Hazards in Fogafale).

Several intervention locations along the high value lagoon shore were assessed (Figure 4). The scoping report identified that of the 'zones' along the high value coast, either zones 3 and 4, or zone 6 were those that would be most suitable for TCAP to target under the project.

Zones 3 and 4 currently have a buffer of a sand beach providing them with some level of resilience to marine flooding; however, the beach is artificial and without ongoing and

substantive nourishment works, it will eventually be lost though erosion, which will increase the vulnerability of this shoreline zone significantly.

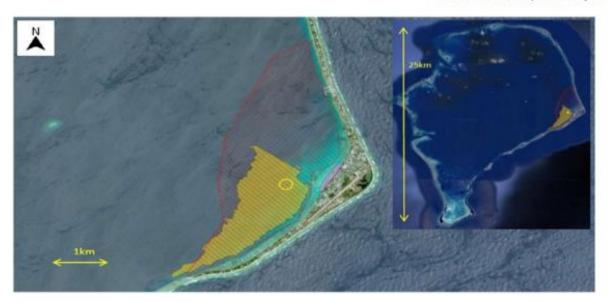
A suitably experienced and qualified contractor would be required to comply with the ESIA in completing the works. The ESIA identified a primary resource area (see Figure 6) with a sediment volume of 24 million m³, and an indicative location for the proposed TCAP aggregate source area (shown by the yellow circle in Figure 6). The volume of sediment required for the TCAP reclamation (250,000m³) accounted for only 1% of the total identified resource in the primary resource area. Therefore, there would be enough material for the reclaimed land.

Figure 6. Indicative location of the proposed TCAP aggregate source area shown by the yellow circle. The yellow polygon is the primary resource area.

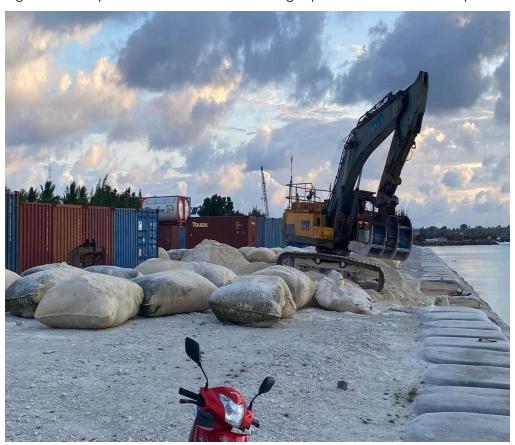
We observed that during the defect liability period of one year, the contractor did some maintenance to some of the GSC units in several areas of the reclaimed land. A small number of units that had been misplaced or damaged were replaced with new ones. Figure 9 is a picture taken by the auditors when the contractor was working on replacing some of the GSC units. TCAP PMU clarify that this repair was due to a construction fault with the underlying geotextile layer causing small voids at the crest of the structure. These bags were removed so that the underlying layer could be correctly placed. The bags were checked for damage during removal and then replaced.

It is important that the GSC units are regularly inspected and maintained by who is responsible for maintaining them to ensure that they provide protection from wave action over time.

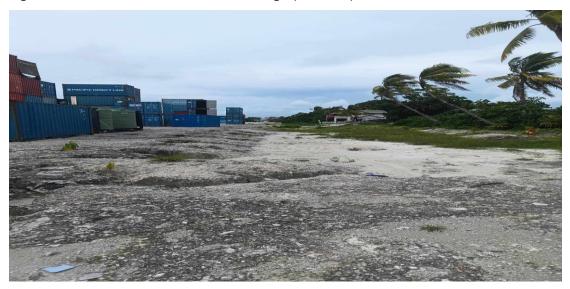
In the structural plan, the reclaimed land slopes down towards the drainage that lies between the mainland and the reclaimed land. There are rills (erosion features) at the edges of the drainage, as shown in Figures 10 & 11, caused by heavy rain. The pictures show only parts of the reclaimed land drainage, but most of the drainage along the reclaimed land has similar rills. Drainage works have occurred to alleviate the concern of neighboring properties of flooding from the reclaimed land into the village. Vegetation of the land and building on it are also expected to reduce the occurrence of rills. According to TCAP PMU the initial design and intent of the reclaimed land was to provide a low-maintenance structure, aimed to meet sea level rise and wave inundation threats and this is why a sloped structure was suggested and approved. Once building atop the reclamation has begun, drainage will subsequently change, howve4r the underlying structure will be one that drains to the swale. The QEII reclamation is an example of what will occur if drainage is not considered. The entire surface is riddled with potholes, puddles and mud after even a day of rain.

Figure 10. Funafuti reclaimed land drainage (auditors)

- conducts a thorough assessment of the state of drainage along the reclaimed land to identify the extent of erosion and associated drainage problems and implements corrective measures.
- conducts a thorough assessment of the state of the main access road to identify the extent of structural concerns and associated flooding problems and implements corrective measures.
- puts in place a regular inspection and funded maintenance programme for the geosynthetic sand container armor units, drainage, access road and other infrastructure along the reclaimed land to ensure that they provide effective mitigation of the impacts of wave action over time.
- maintains regular and open communication with households living alongside the reclaimed land to identify and resolve problems affecting them associated with maintenance of the reclaimed land quickly and effectively, wherever possible.

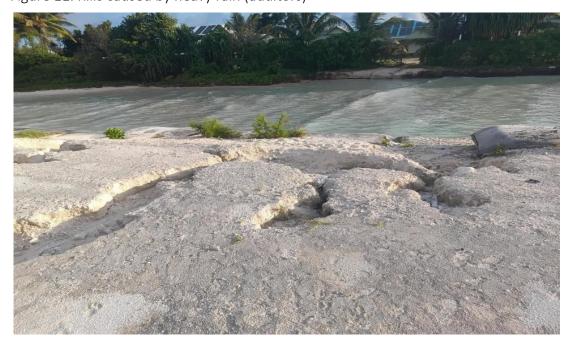
Figure 11. Rills caused by heavy rain (auditors)

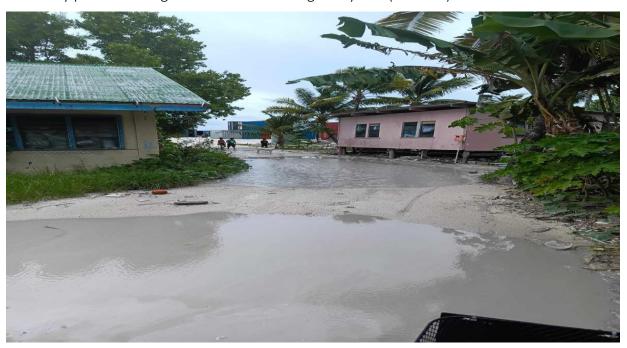
From our interviews of households who live along the coastal area adjacent to the reclaimed land, one household complained about the road access to the reclaimed land outside their house. Due to the number of vehicles going in and out of the reclaimed land, big potholes had been created where water got trapped during heavy rain causing flooding near their home (see Figure 12). In the design structural plan, this area is the main road access to the reclaimed land. The potholes therefore need to be fixed and the road properly maintained. During the period of the audit, we witnessed the continuous maintenance to this road; however, the issue kept recurring during periods of heavy rain, as the potholes would quickly re-form, trapping water and causing repeated flooding near the household's property.

Figure 12. Flooding outside homes adjacent to the main access road to the recliamed land, caused by potholes filling with rain water during heavy rain (auditors)

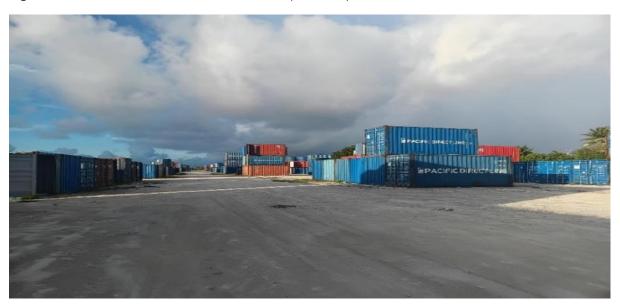
We also found that the reclaimed land was being used for other purposes such as to temporarily store almost 400 containers, as shown in Figure 13. These containers were moved from wharf which helped in wharf rehabilitation as there was no other storage place on the island.

Figure 13. Containers at the reclaimed land (auditors)
